Technical Bulletin

Subject: **Eliminating wind noises**

Models(s): **Passat 1995 m.y.**

Number: **94-01**

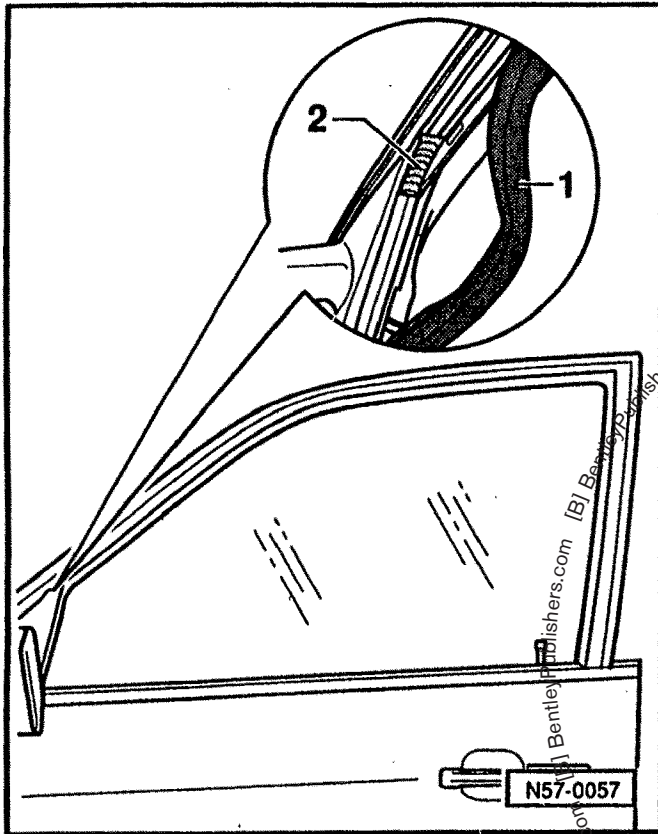
Front doors at A-pillar

Resonance can occur at the outer/lower window guide vulcanization point.

- Pull off cover in front corner of door frame.
- Pull off inner window guide -1-.
- Apply felt strip -2- (size 40 x 10 x 3 mm)
Part No. 533 863 288 A, to area indicated.

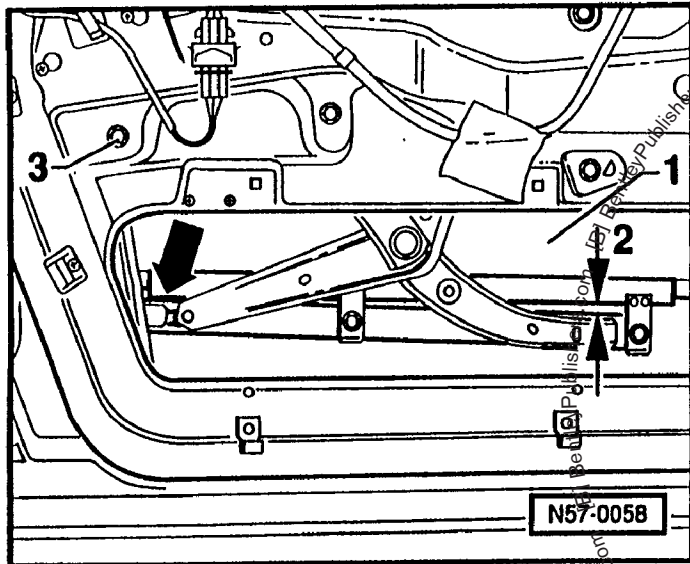
Front doors with power windows

When the door windows are lowered, the door outer panel is pushed outward or the window slot seal is lifted up. The result is a roaring noise at the window slot.

Check the setting of the door window and adjust if necessary.

- Remove door trim panel and vapor barrier.
- Front of window -1- must be raised 2.0 mm from window regulator -2- and sit properly at the rear (arrow)
- Rear securing point -3- of lower guide rail must be set downward to the stop.
- Window must be aligned parallel to window guide.

The window must not be tilted forward as it could then become derailed from the window guide.

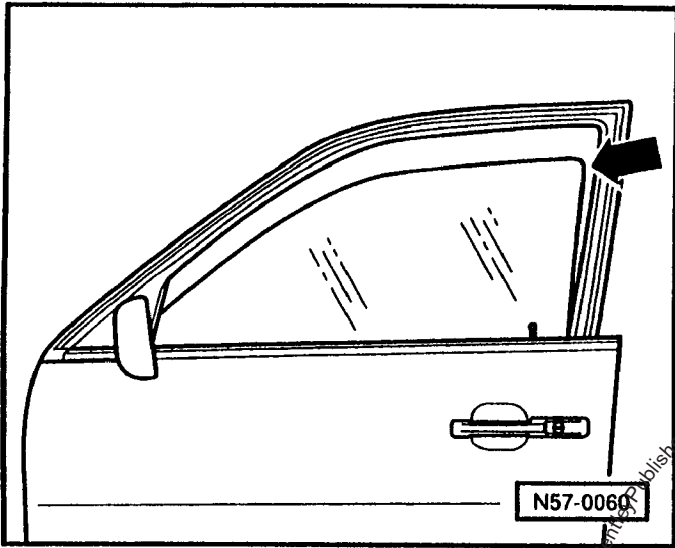
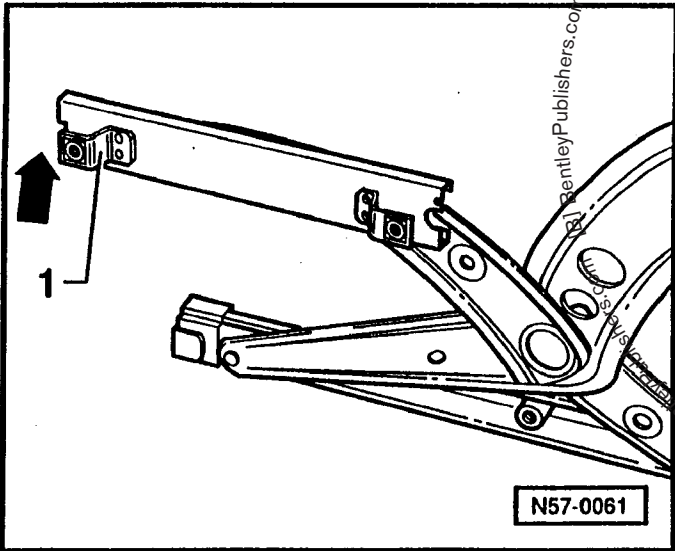
Front doors at B-pillars

The window is tilted forward resulting in an insufficient seal to the outer window guide at the B-pillar (arrow).

- Check setting of window as described under "Front doors with power windows" on page 50-2. Adjust window as necessary.

- If window cannot be adjusted as described, remove window regulator.

- Bend rear securing point -1- of the lower guide rail up about 1.0 mm.

- Reinstall window regulator and adjust window as necessary.

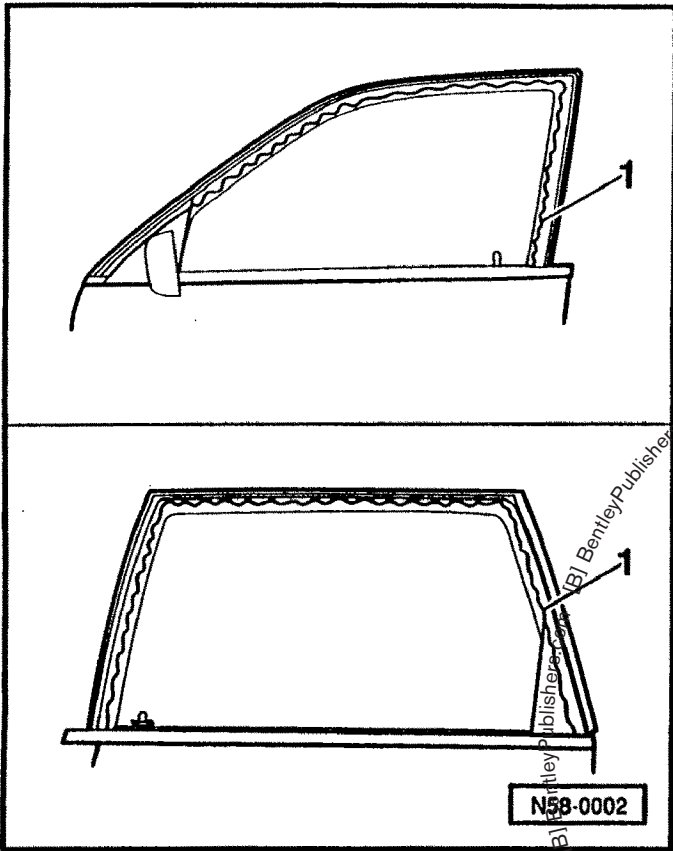
Doors – warped window guides

Loud airflow and resonance noises, especially at the B and C-pillars.

- Replace window guides -1-.

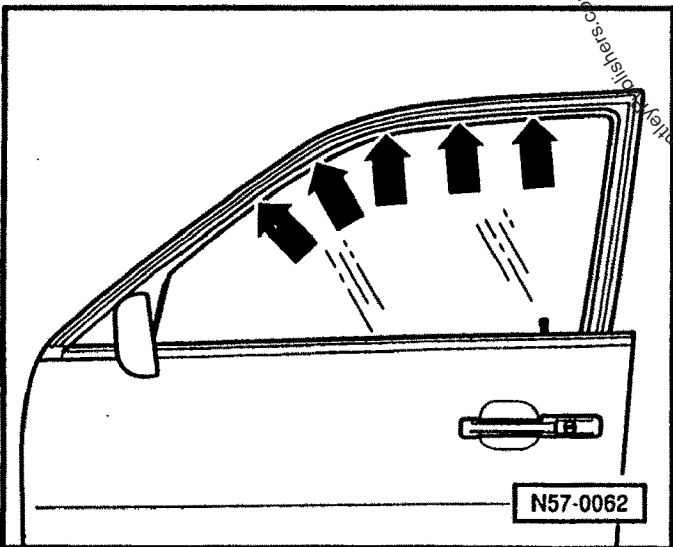
Doors – window guides not opened out

Window guides that are not sufficiently opened out can transmit noises due to gaps (arrows) between window and guide.

- Open out window guides evenly.

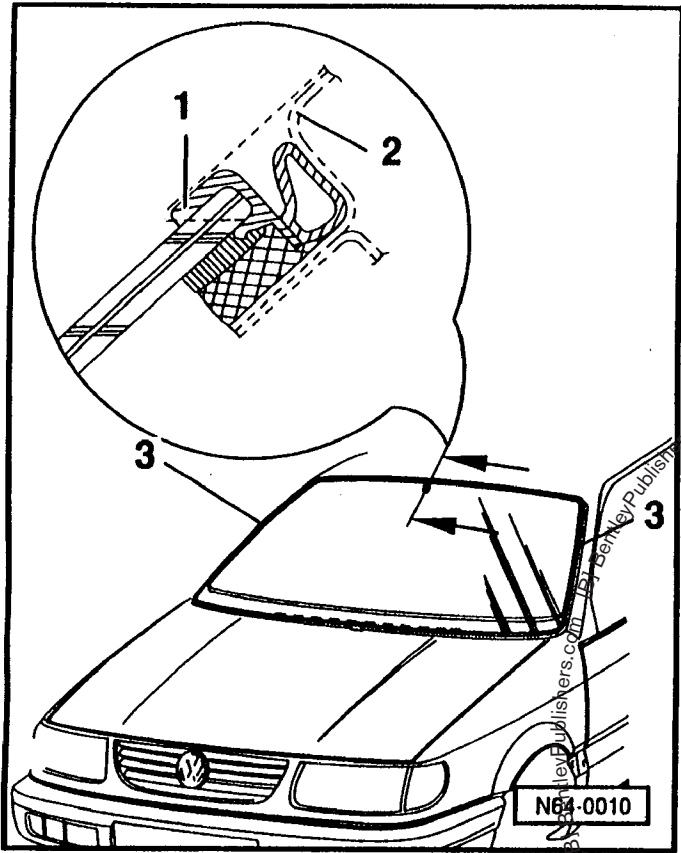
Windshield – too high in opening

A windshield placed too high in the opening can cause loud airflow noises.

– Remove windshield.

– Install windshield and press in until frame -1- is flush with roof -2- and A-pillars -3-.

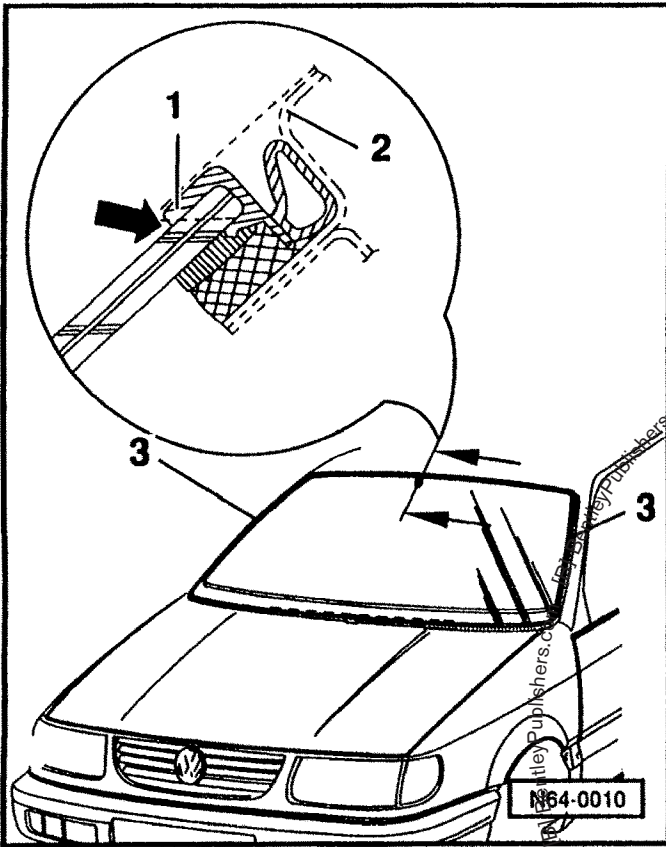
Windshield – gap between glass and frame

Loud roaring noises are produced if the windshield frame -1- is not evenly seated on the windshield glass.

- Seal gap (arrow) with sealant, Part No. D 001 007 or equivalent!

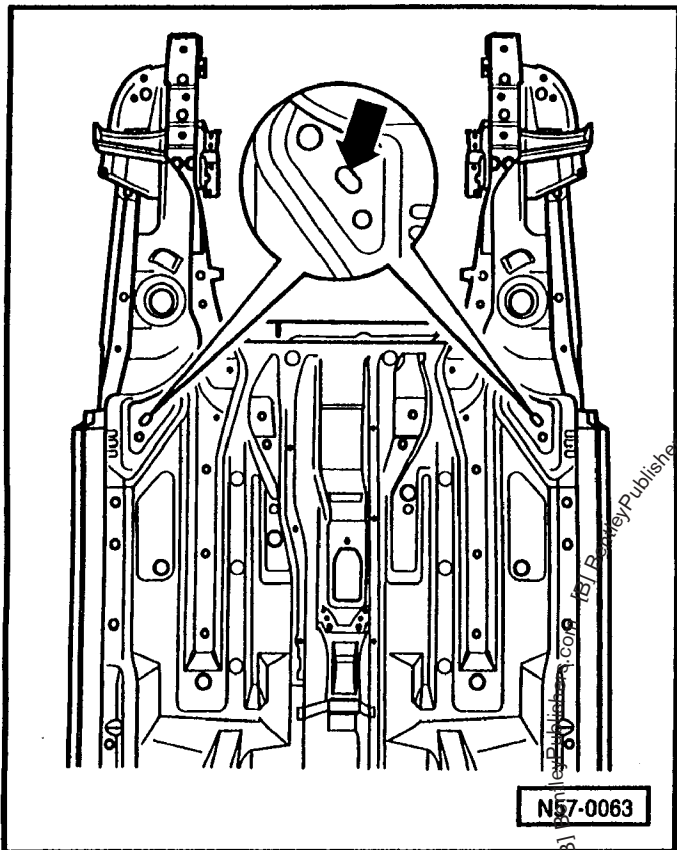
"Howling" wind noise

These noises start at approx. 50 mph (80 km/h) and are presumed to be coming from the area behind the rear doors.

- Replace missing oval plugs (arrow) in floor panel.
Part No. N 904 028 01.
